NASA/TP-97-206257

The Characteristics of Fatigue Damage in the Fuselage Riveted Lap Splice Joint

Robert S. Piascik
Langley Research Center, Hampton, Virginia

November 1997

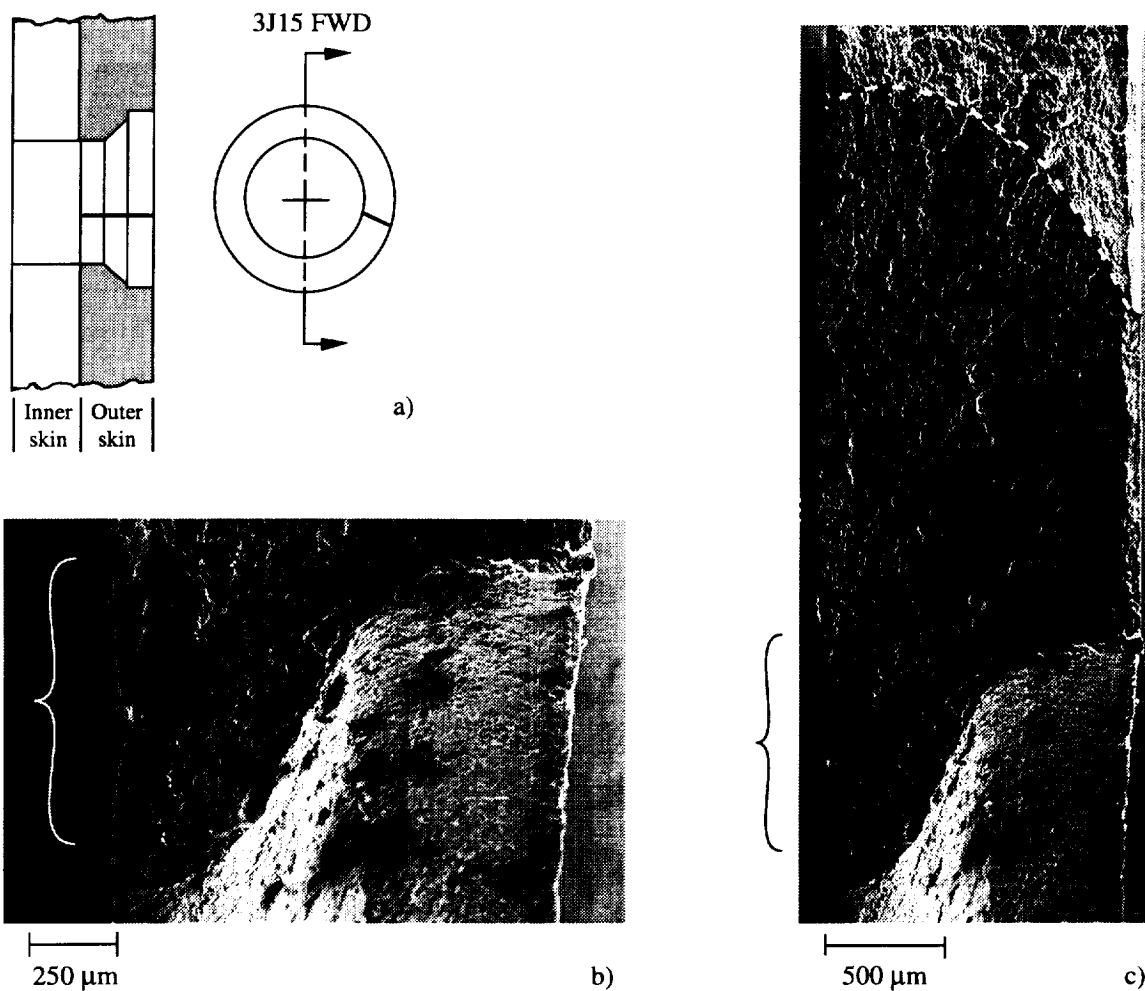
Figure 9.31 a) The schematic shows the rivet hole 3J15 configuration and the location of the outer skin fatigue crack oriented in the forward direction below the 9 o'clock position. b) The SEM micrograph shows the fatigue crack at the rivet hole. The bracket marks the likely region of crack initiation along the faying surface. c) The SEM micrograph shows the fatigue crack at the rivet hole (bottom). The bracket locates the region of crack initiation along the faying surface and the dashed line marks the fatigue crack front.

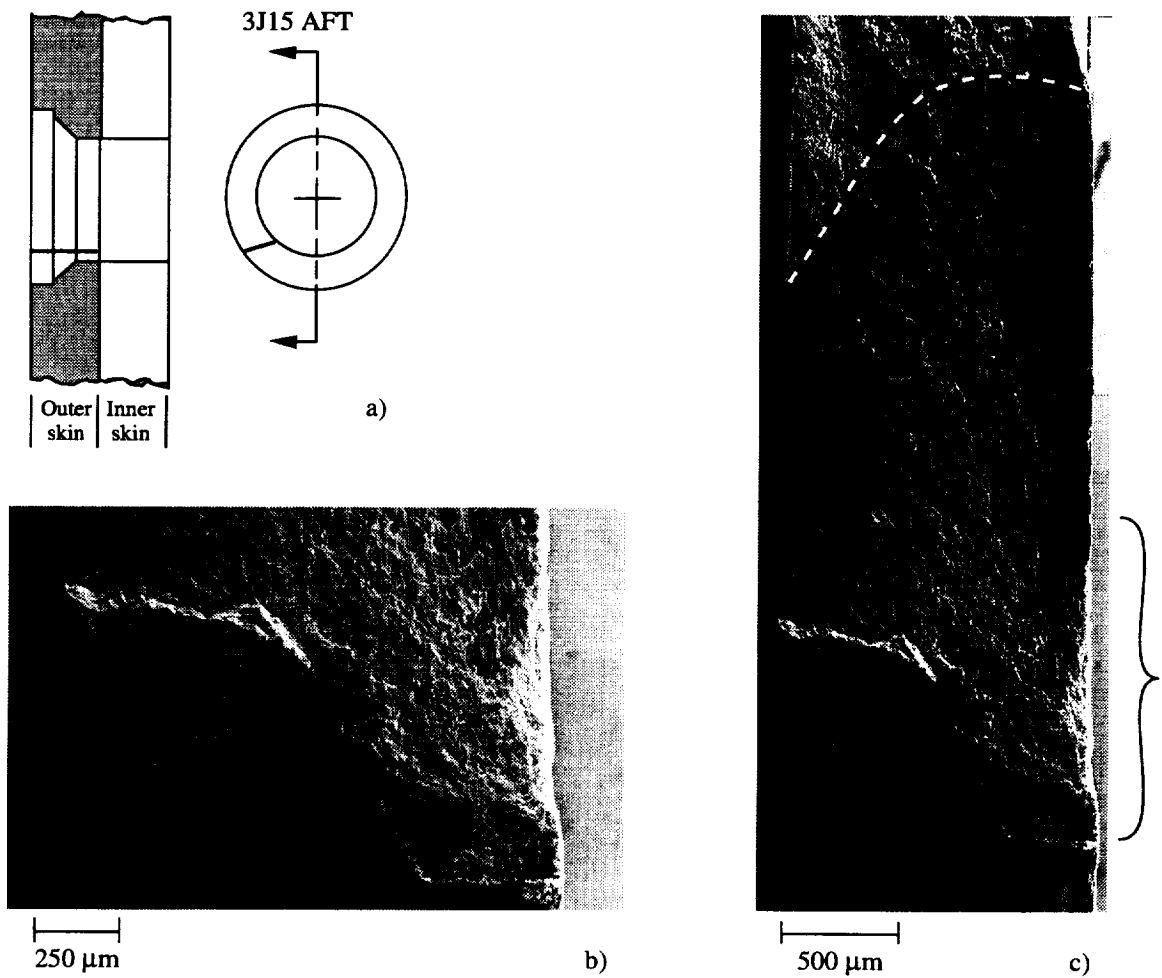
Figure 9.32 a) The schematic shows the rivet hole 3J15 configuration and the location of the outer skin fatigue crack oriented in the aft direction and about the 8 o'clock position. b) The SEM micrograph shows the fatigue crack region, marked by the bracket in Figure 9.32.c, at high magnification. c) The SEM micrograph shows the fatigue crack at the rivet hole (bottom). The bracket locates the region of crack initiation along the faying surface and the dashed line marks the fatigue crack front.

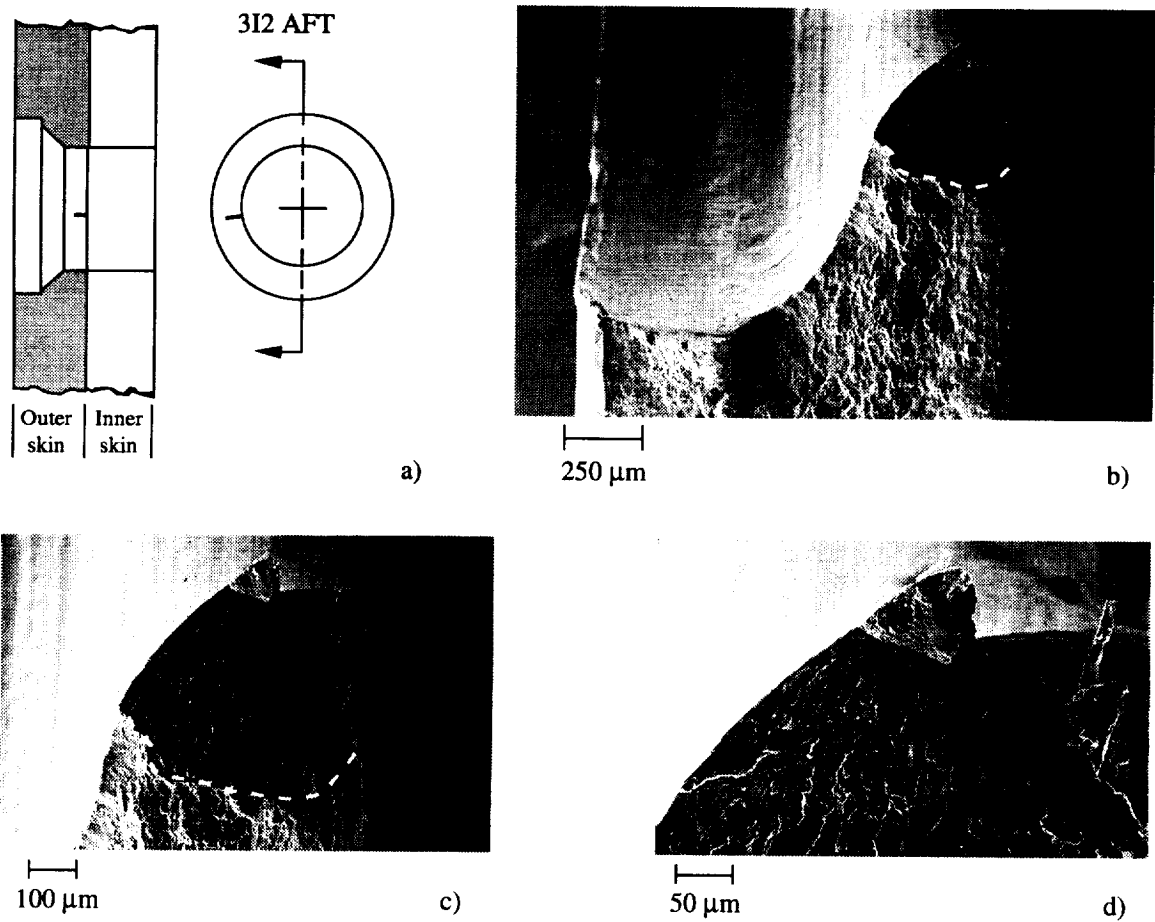
Figure 9.34 a) The schematic shows the rivet hole 3I2 configuration and the location of the outer skin fatigue crack oriented in the aft direction below the 9 o'clock position. b) The SEM micrograph shows the fatigue crack and the rivet hole. The dashed line marks the fatigue crack front. c) The SEM micrograph shows the fatigue crack region. The dashed line marks the fatigue crack front. d) The SEM micrograph shows the region of crack initiation at the deformed rivet hole shank.

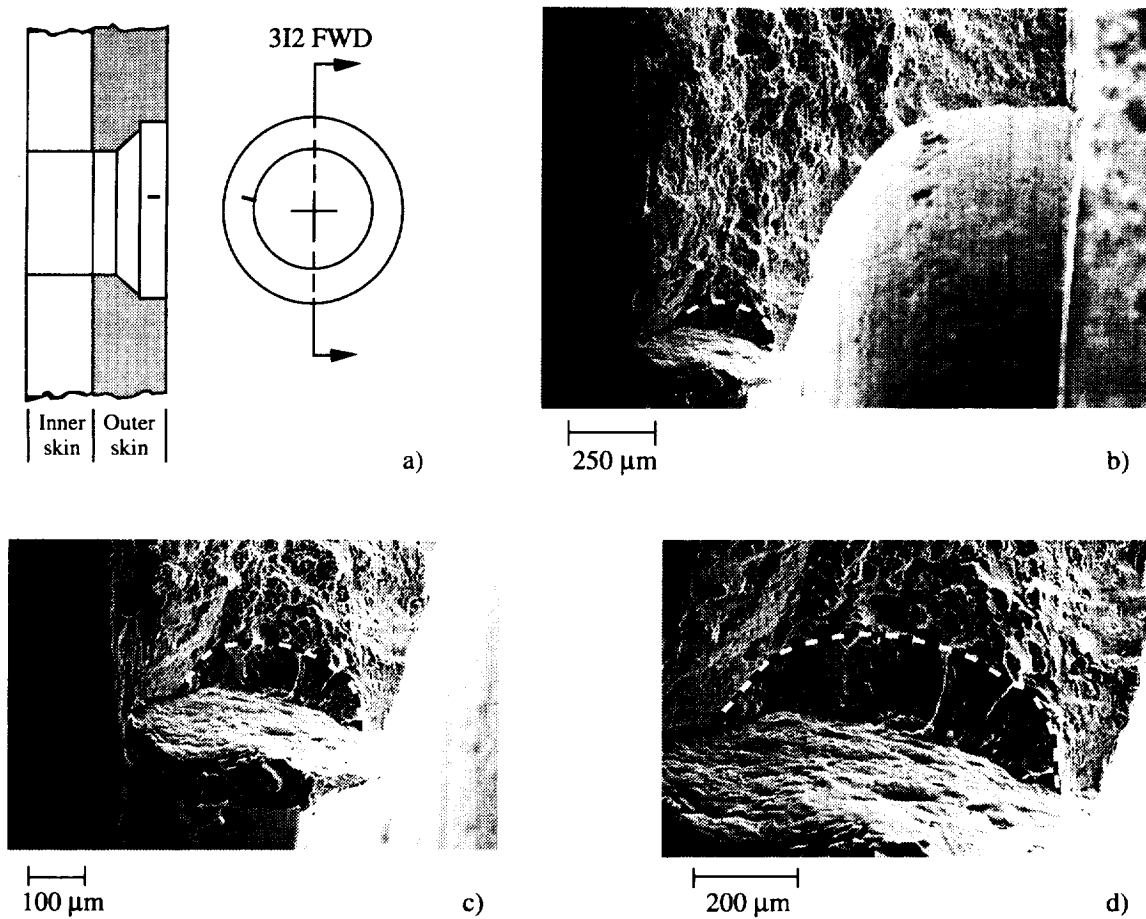
Figure 9.35 a) The schematic shows the rivet hole 3I2 configuration and the location of the outer skin fatigue crack oriented in the forward direction above the 9 o'clock position. b) The SEM micrograph shows the fatigue crack and the rivet hole. The dashed line marks the fatigue crack front. c) The SEM micrograph shows the rivet hole shank region. The dashed line marks the fatigue crack front. d) The SEM micrograph shows the region of crack initiation at the rough surface of the rivet hole shank.

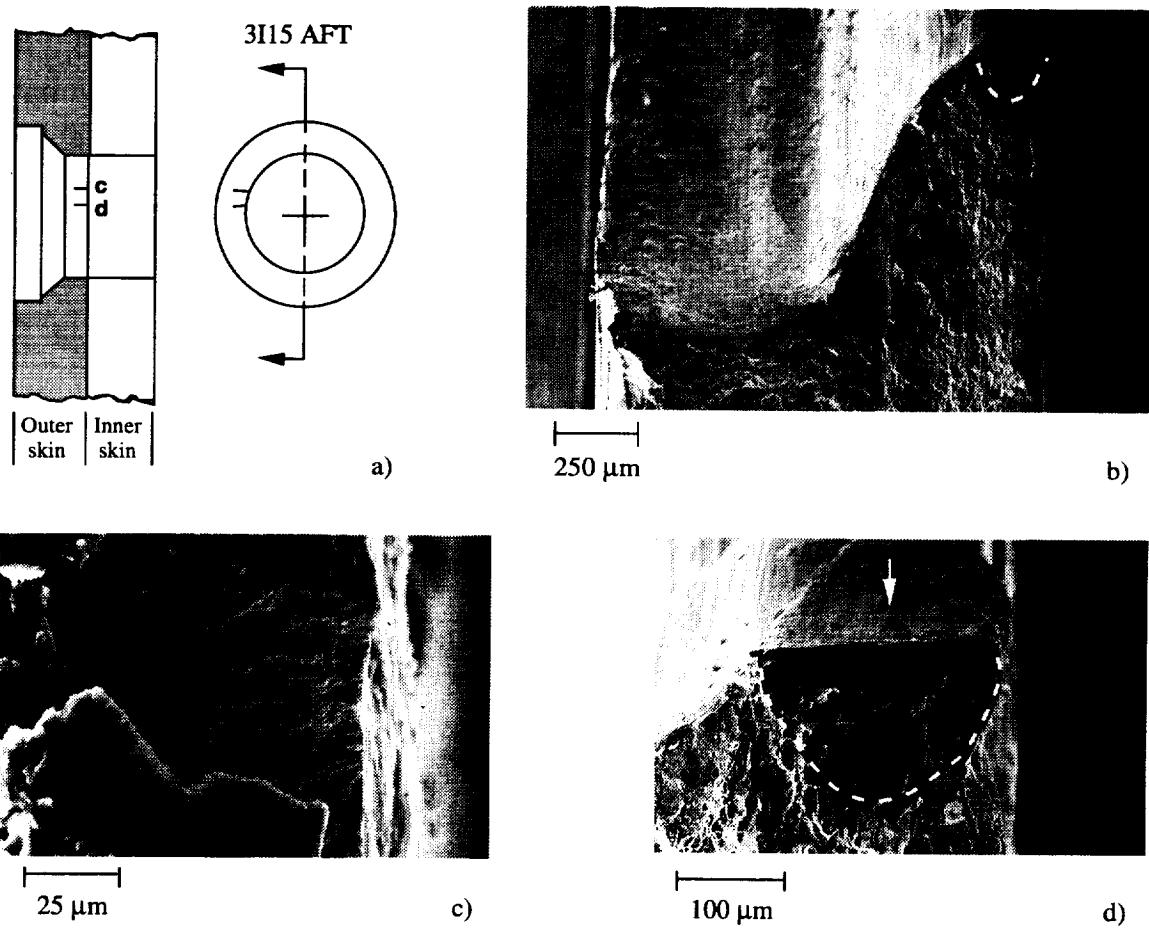
Figure 9.38 a) The schematic shows the rivet hole 3I15 configuration and the location of two outer skin fatigue cracks ("c" and "d") oriented in the aft direction and about the 9 and 10 o'clock positions. b) The SEM micrograph shows fatigue crack "d" at the rivet hole. The dashed line marks the fatigue crack front. c) The SEM micrograph shows the partially opened fatigue crack "c" in Figure 9.38.a located at the inboard corner of the rivet hole. d) The SEM micrograph shows the fatigue crack "d" located at the rivet hole shank.

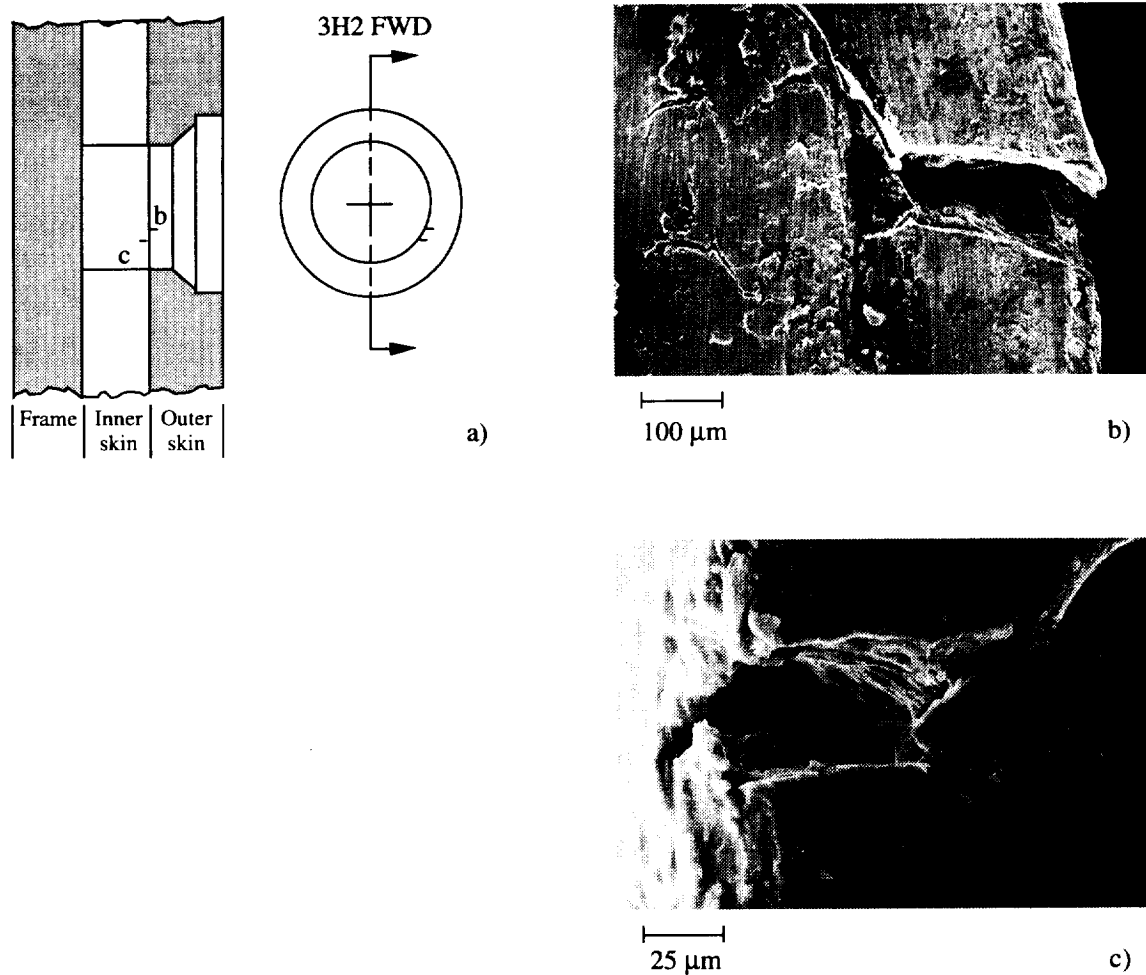
Figure 9.39 a) The schematic shows the rivet hole 3H2 configuration and the location of two fatigue cracks, ("b" and "c") oriented in the forward direction and about the 4 o'clock position. Crack "b" is located at the outboard corner of the inner skin and crack "c" is located at the inboard corner of the outer skin rivet hole. b) The SEM micrograph shows the partially opened inner skin fatigue crack "b" shown in Figure 9.40.a. c) The SEM micrograph shows the partially opened outer skin fatigue crack "c" shown in Figure 9.40.a.

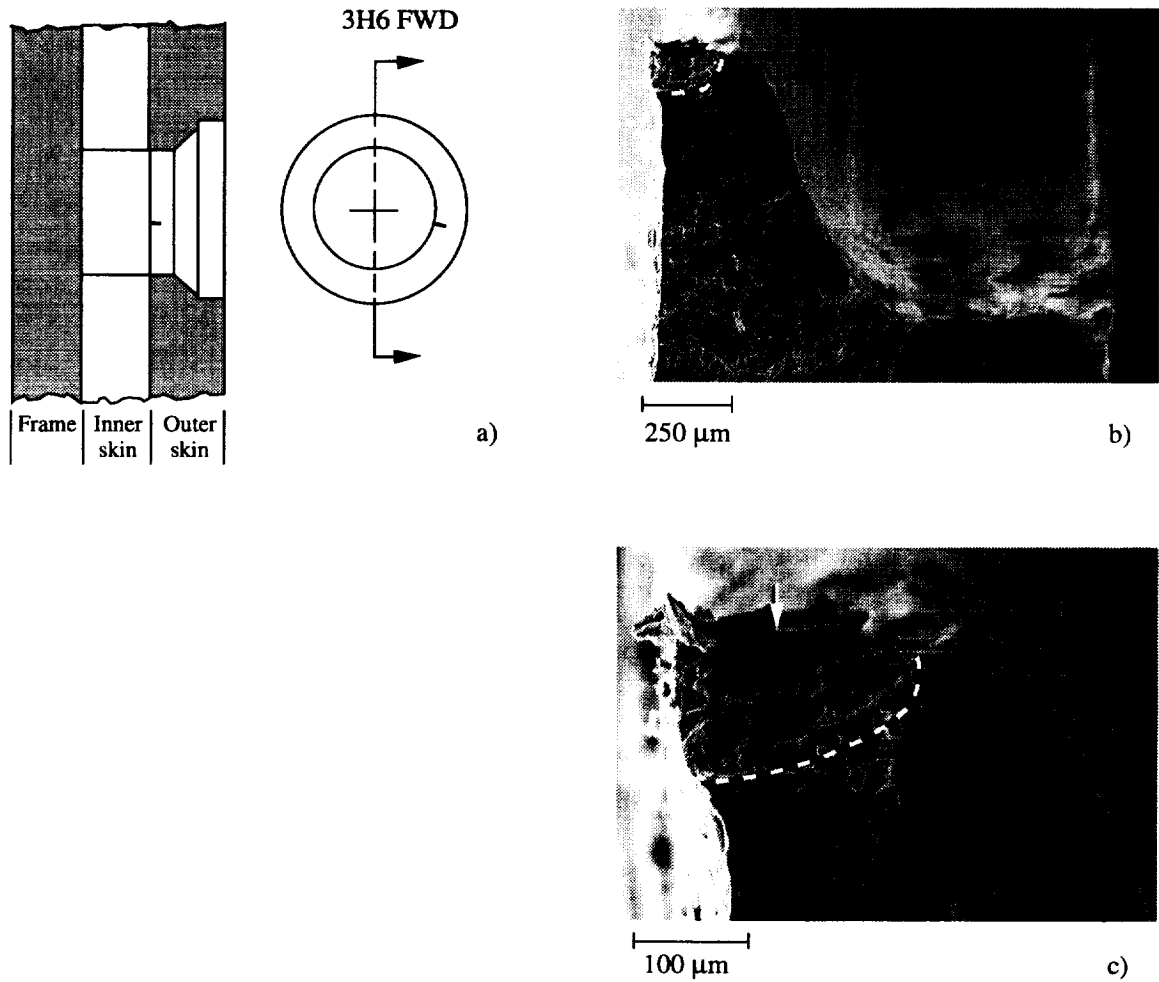
Figure 9.40 a) The schematic shows the rivet hole 3H6 configuration and the location of the outer skin fatigue crack oriented in the forward direction below the 3 o'clock position. b) The SEM micrograph shows the fatigue crack at the rivet hole shank region. The dashed line marks the fatigue crack front. c) The SEM micrograph shows the region of crack initiation (arrow) at the rivet hole shank. The dashed line marks the fatigue crack front.

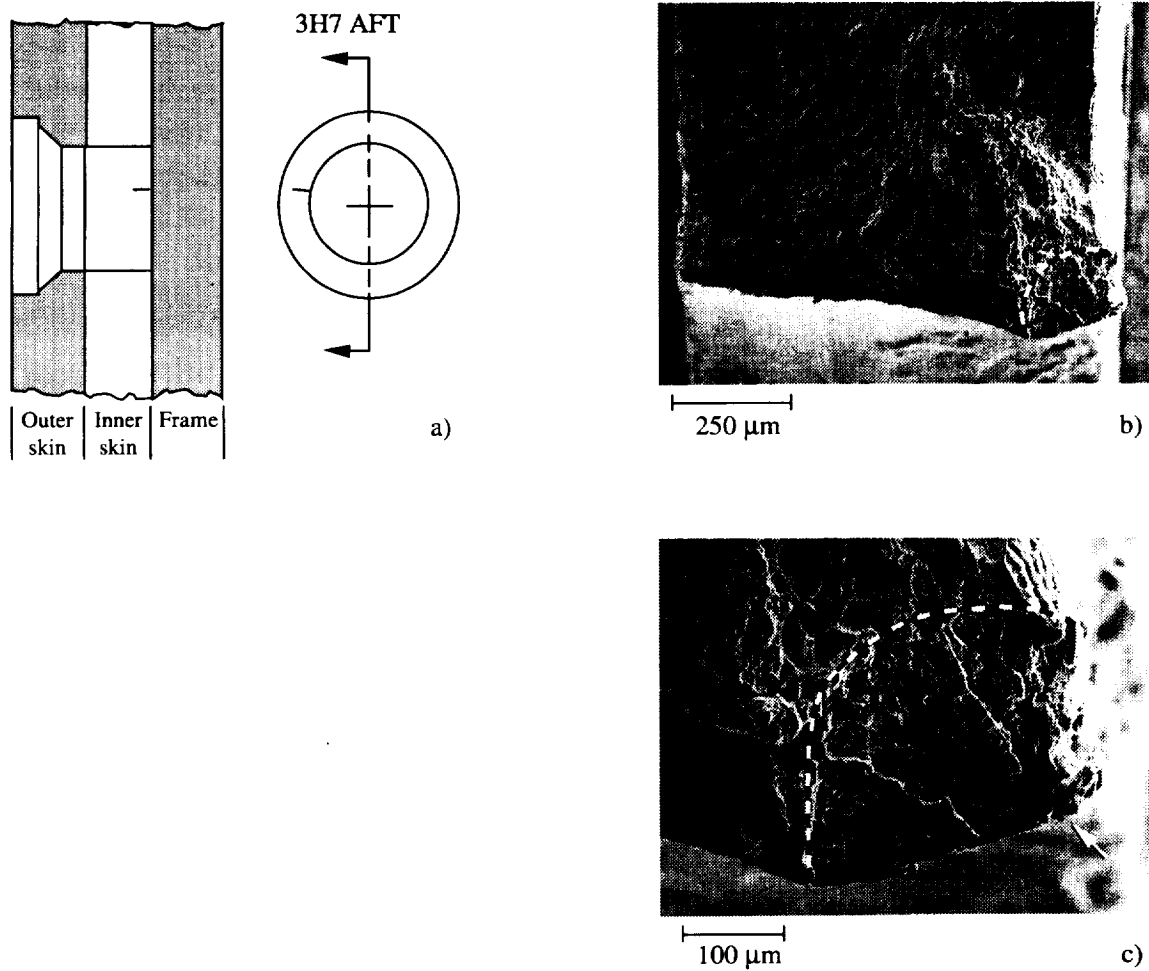
Figure 9.41 a) The schematic shows the rivet hole 3H7 configuration and the location of the inner skin fatigue crack oriented in the aft direction above the 9 o'clock position. b) The SEM micrograph shows the fatigue crack at the inboard corner of the rivet hole. The dashed line marks the fatigue crack front. c) The SEM micrograph shows the region of crack initiation (arrow) at the inboard corner of the rivet hole. The dashed line marks the fatigue crack front.

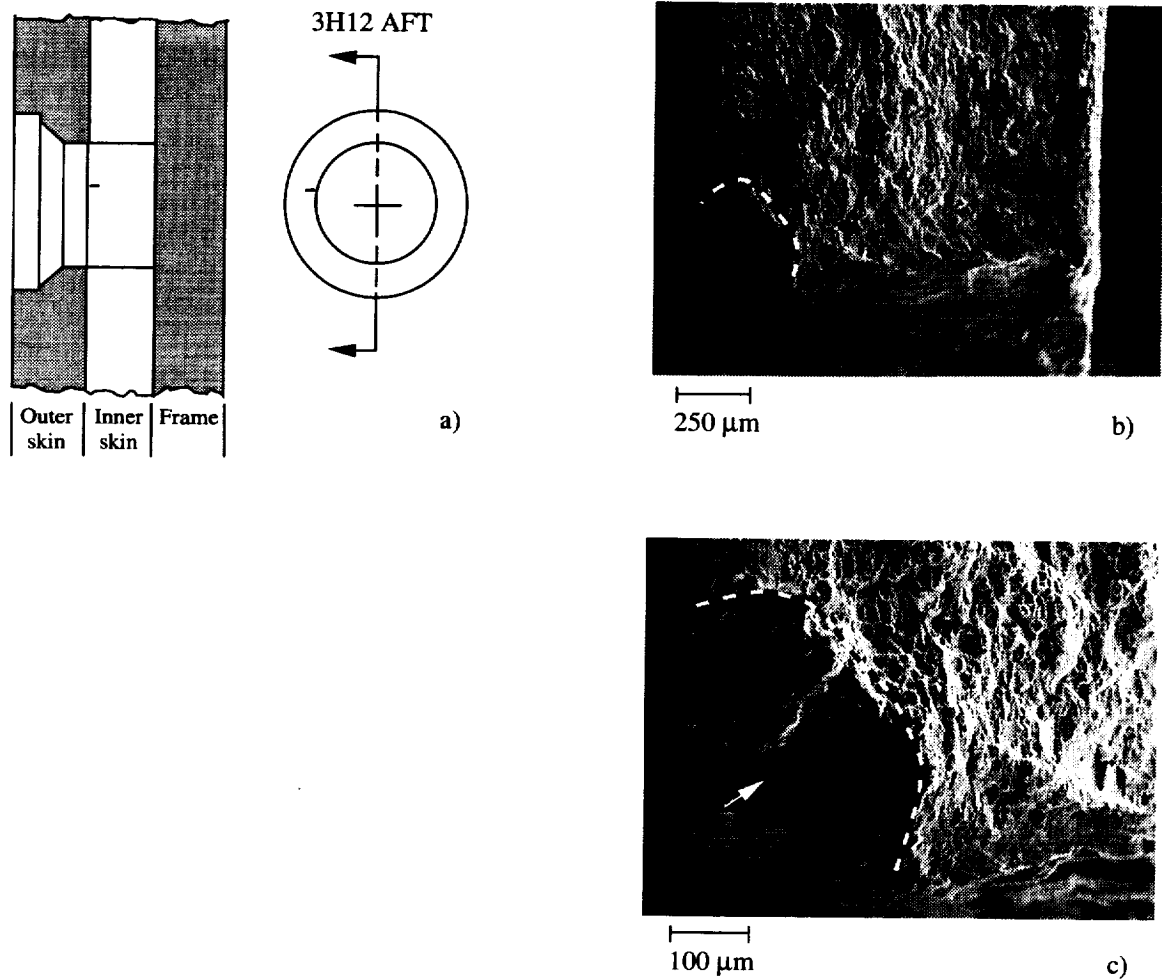
Figure 9.42 a) The schematic shows the rivet hole 3H12 configuration and the location of the inner skin fatigue crack oriented in the aft direction above the 9 o'clock position. b) The SEM micrograph shows the fatigue crack at the outboard corner of the rivet hole. The dashed line marks the fatigue crack front. c) The SEM micrograph shows the region of crack initiation (arrow) at the outboard corner of the rivet hole. The dashed line marks the fatigue crack front.

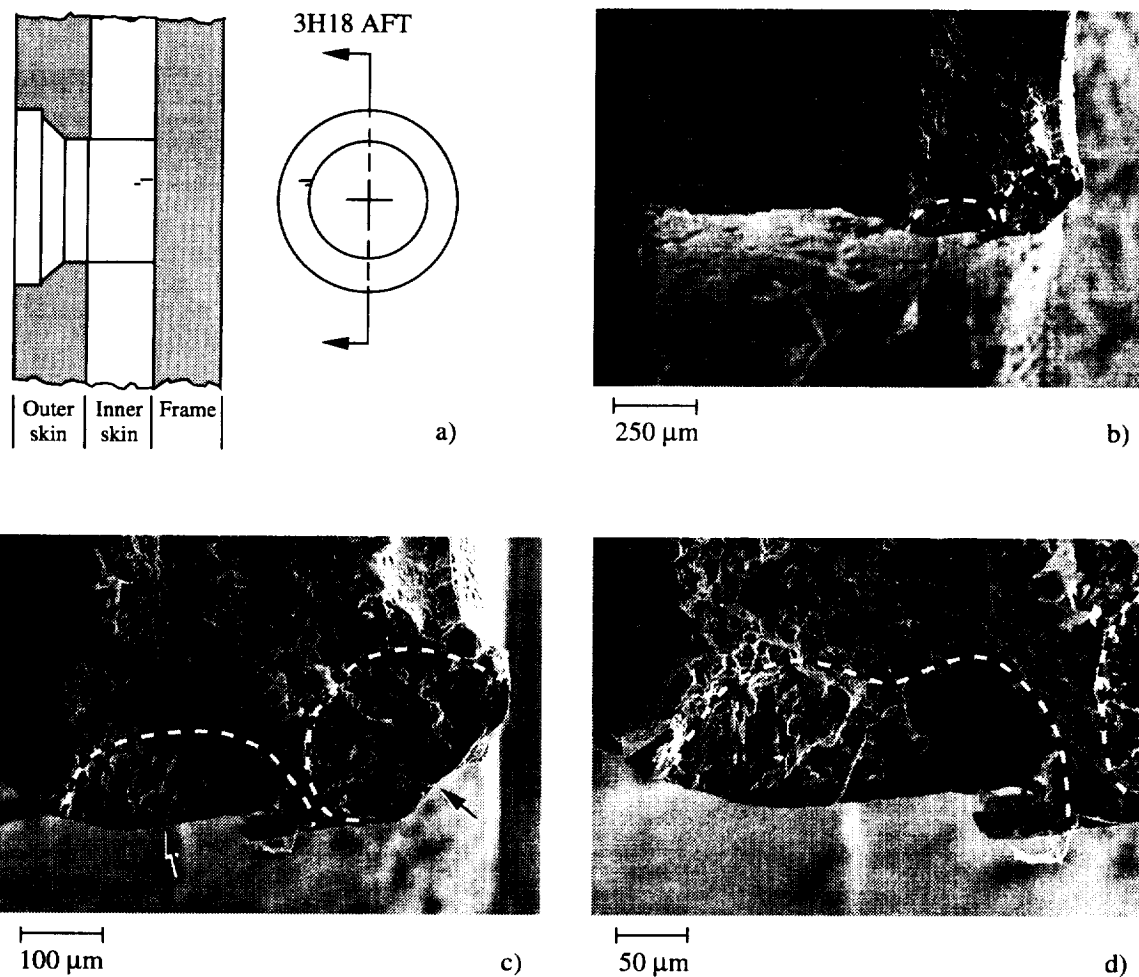
Figure 9.43 a) The schematic shows the rivet hole 3H18 configuration and the location of two inner skin fatigue cracks oriented in the aft direction above the 9 o'clock position. b) The SEM micrograph shows the fatigue cracks at the inboard corner of the rivet hole and at the rivet hole surface. The dashed lines mark the fatigue crack front. c) The SEM micrograph shows the region of crack initiation (arrows) of the inboard corner and surface fatigue cracks. The dashed lines mark the fatigue crack fronts. d) The SEM micrograph shows the rivet hole surface crack at high magnification.

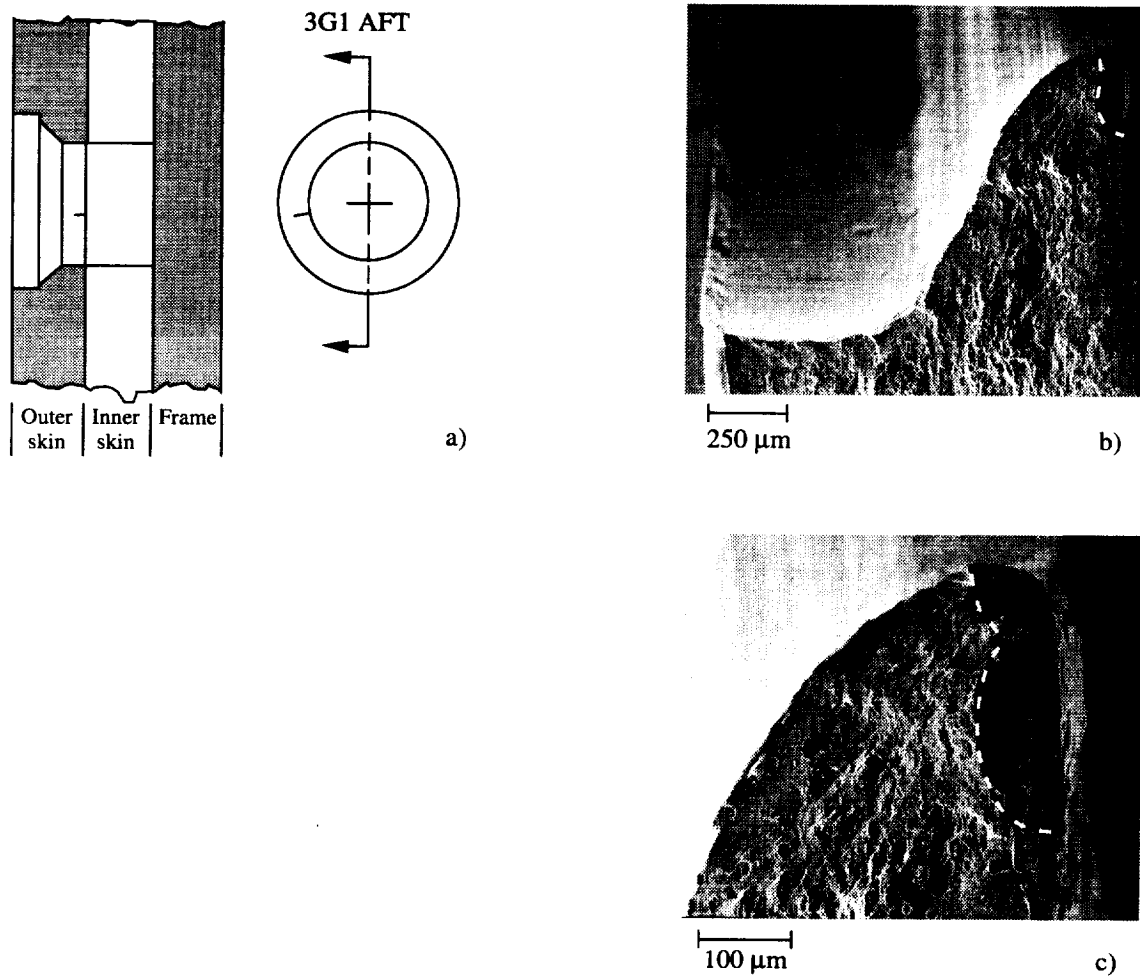
Figure 9.44 a) The schematic shows the rivet hole 3G1 configuration and the location of the outer skin fatigue crack oriented in the aft direction below the 9 o'clock position. b) The SEM micrograph shows the fatigue crack at the rivet hole faying surface. The dashed line marks the fatigue crack front. c) The SEM micrograph shows the fatigue crack region at high magnification. The dashed line marks the fatigue crack front.

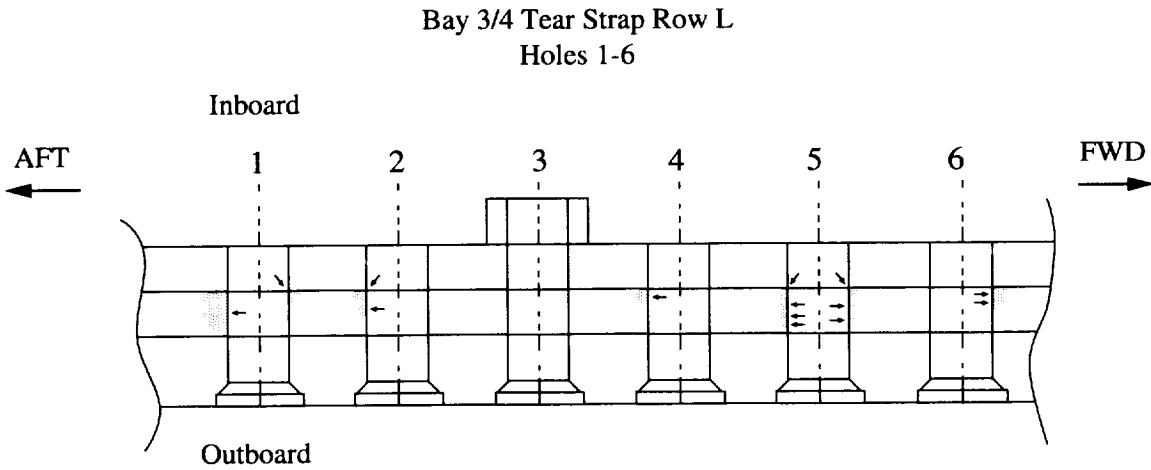
Hole #	Location	Length mm(in)	Type	Initiation site
1 (Aft)	Upper tear strap	2.388 (0.094)	Through	Surface
1 (Fwd)	Upper tear strap	0.143 (0.006)	Corner	Inboard corner
2 (Aft)	Upper tear strap	0.176 (0.007)	Corner	Multiple inboard corner
2 (Aft)	Upper tear strap	0.336 (0.013)	Surface	Surface
4 (Aft)	Upper tear strap	0.353 (0.014)	Corner	Surface
5 (Aft)	Upper tear strap	0.180 (0.007)	Surface	Multiple surface
5 (Aft)	Upper tear strap	0.171 (0.007)	Corner	Inboard corner
5 (Fwd)	Upper tear strap	0.619 (0.024)	Corner	Inboard corner
5 (Fwd)	Upper tear strap	0.143 (0.006)	Surface	Multiple surface
6 (Fwd)	Upper tear strap	0.603 (0.024)	Corner	Multiple surface

Figure 10.5 The through the thickness row schematic shows the location and initiation site of fatigue cracks found in holes number 1, 2, 3, 4, 5, and 6 (row L) in the bay 3/4 tear strap. The table summarizes crack location, crack length, crack type, and initiation site for each fatigue crack shown.

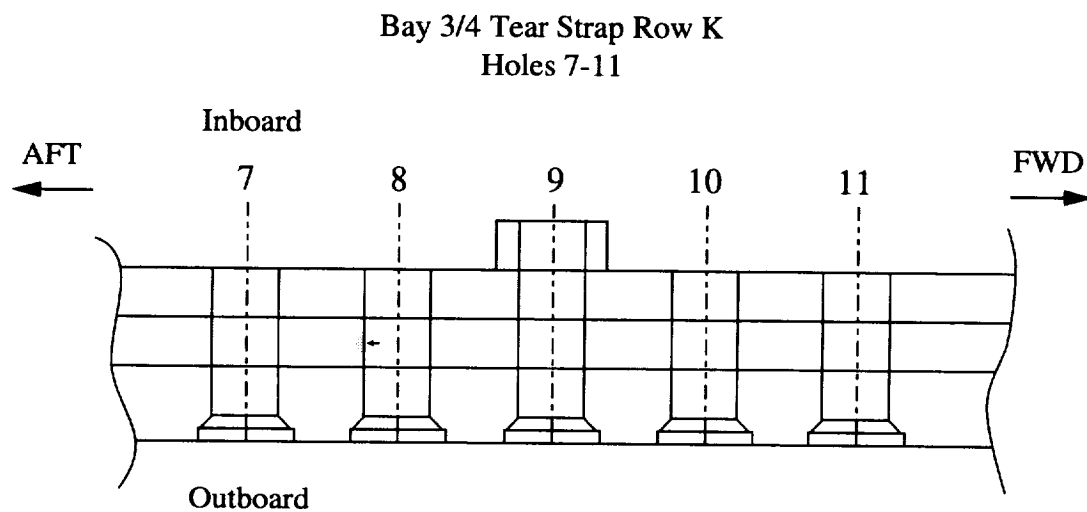
Hole #	Location	Length mm(in)	Type	Initiation site
8 (Aft)	Upper tear strap	0.069 (0.003)	Surface	Surface

Figure 10.6 The through the thickness row schematic shows the location and initiation site of fatigue cracks found in holes number 7, 8, 9, 10, and 11 (row K) in the bay 3/4 tear strap. The table summarizes crack location, crack length, crack type, and initiation site for each fatigue crack shown.

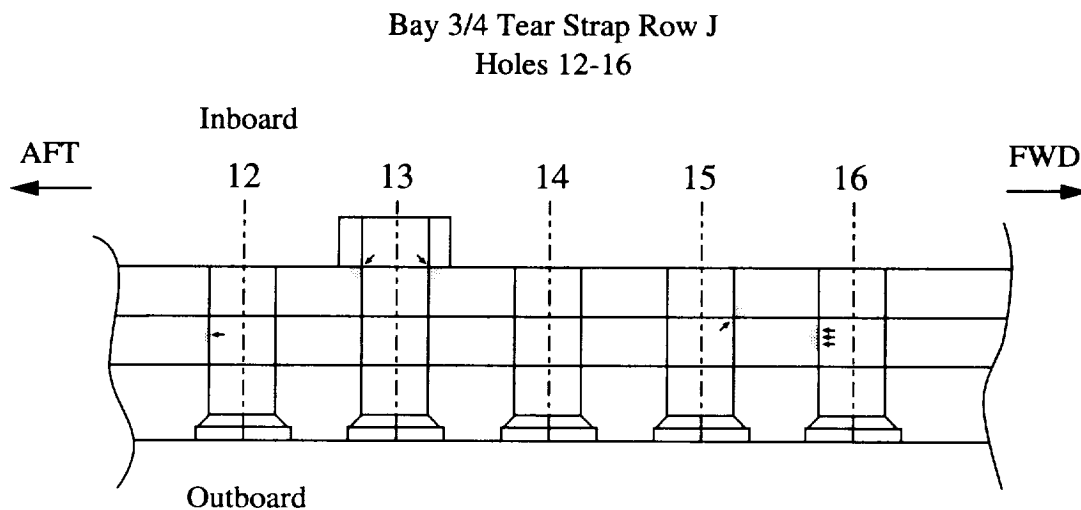
Hole #	Location	Length mm(in)	Type	Initiation site
12 (Aft)	Upper tear strap	0.284 (0.011)	Surface	Surface
13 (Aft)	Lower tear strap	0.377 (0.015)	Corner	Outboard corner
13 (Fwd)	Lower tear strap	0.177 (0.007)	Corner	Multiple corner
15 (Fwd)	Lower tear strap	0.196 (0.008)	Corner	Outboard corner
16 (Aft)	Upper tear strap	0.076 (0.003)	Surface	Multiple surface

Figure 10.7 The through the thickness row schematic shows the location and initiation site of fatigue cracks found in holes number 12, 13, 14, 15, and 16 (row J) in the bay 3/4 tear strap. The table summarizes crack location, crack length, crack type, and initiation site for each fatigue crack shown.

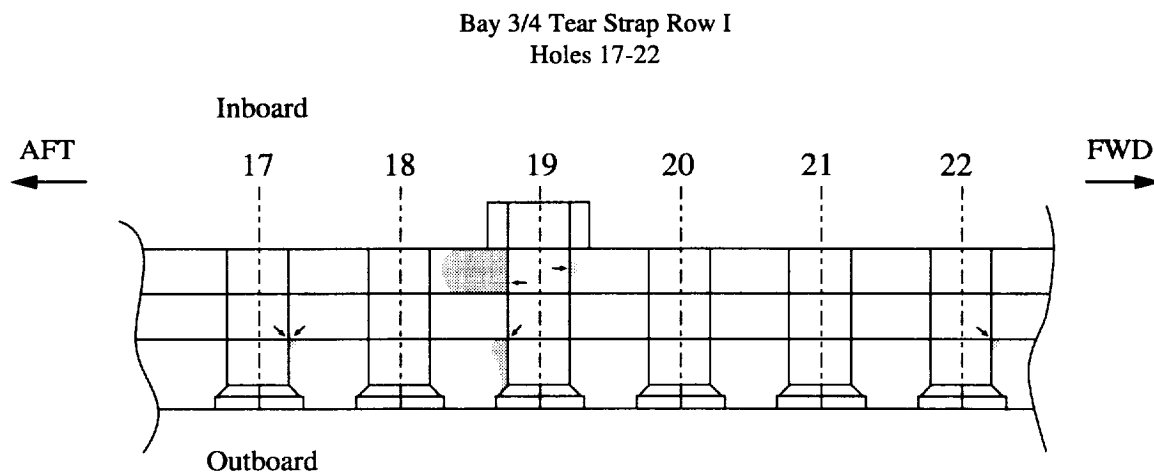
Hole #	Location	Length mm(in)	Type	Initiation site
17 (1 Fwd)	Outer skin	0.216 (0.008)	Countersink	Inboard side of shank
17 (2 Fwd)	Outer skin	0.470 (0.019)	Countersink	Inboard side of shank
19 (1 Aft)	Lower tear strap	5.224 (0.206)	Through	Surface
19 (2 Aft)	Outer skin	0.325 (0.013)	Countersink	Inboard side of shank
19 (Fwd)	Lower tear strap	0.213 (0.008)	Surface	Surface
22 (Fwd)	Outer skin	0.154 (0.006)	Countersink	Inboard side of shank

Figure 10.8 The through the thickness row schematic shows the location and initiation site of fatigue cracks in holes number 17, 18, 19, 20, 21, and 22 (row I) in the bay 3/4 tear strap. The table summarizes crack location, crack length, crack type, and initiation site for each fatigue crack shown.

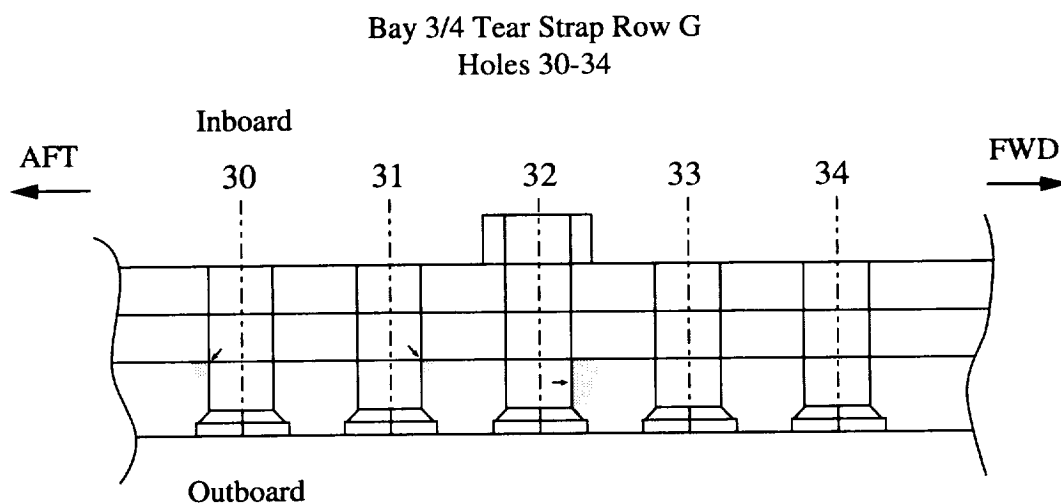
Hole #	Location	Length mm(in)	Type	Initiation site
30 (Aft)	Outer skin	0.208 (0.008)	Countersink	Inboard side of shank
31 (Fwd)	Outer skin	0.123 (0.005)	Countersink	Inboard side of shank
32 (Fwd)	Outer skin	0.529 (0.021)	Countersink	Outboard of shank

Figure 10.9 The through the thickness row schematic shows the location and initiation site of fatigue cracks in holes number 30, 31, 32, 33, and 34 (row G) in the bay 3/4 tear strap. The table summarizes crack location, crack length, crack type, and initiation site for each fatigue crack shown.

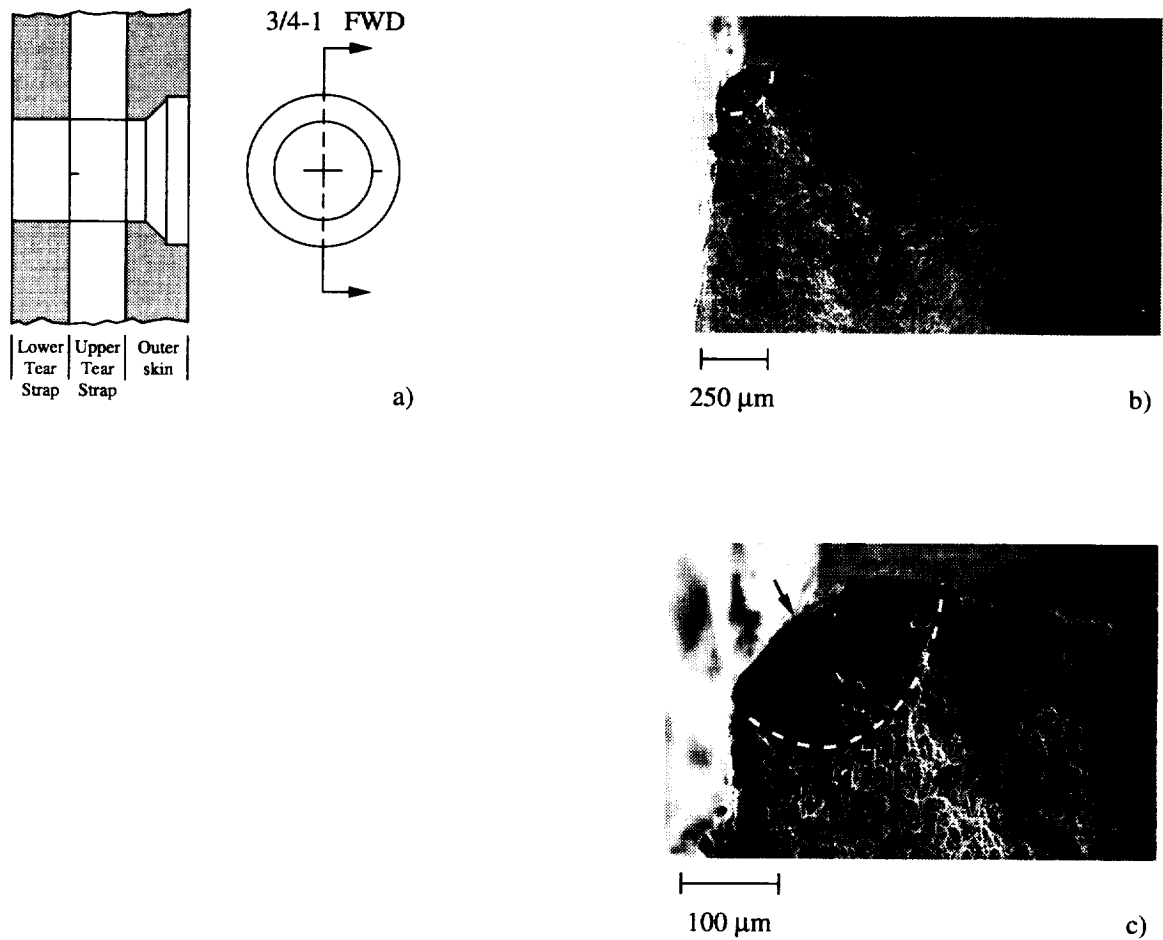
Figure 10.10 a) The schematic shows the rivet hole 3/4-1 configuration and the location of an upper T.S. fatigue crack oriented in the forward direction and about the 3 o'clock position. b) The SEM micrograph shows the location of a small fatigue crack at the inside corner of the upper T.S. rivet hole. The dashed line marks the fatigue crack front. c) The SEM micrograph shows the corner crack at high magnification. The arrow marks the likely crack initiation site and the dashed line marks the fatigue crack front.

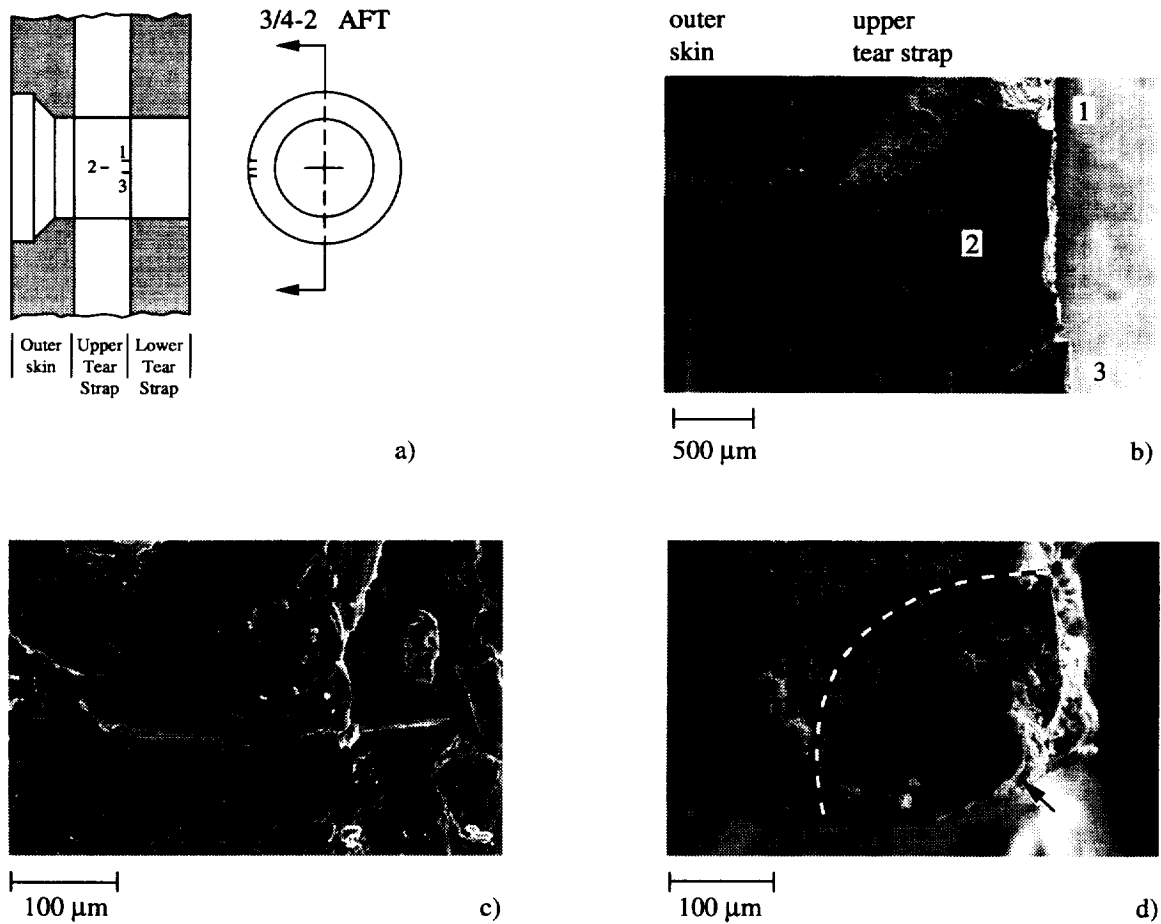
Figure 10.12 a) The schematic shows the rivet hole 3/4-2 configuration and the location of three upper T.S. fatigue cracks oriented in the aft direction and about the 9 o'clock position. b) The SEM micrograph shows the location of two partially opened upper T.S. cracks, crack #2 on the rivet hole surface and crack #3 at the inboard corner. Crack #1 is located at the inboard corner on the main fracture surface. c) The SEM micrograph shows the partially opened fatigue crack #2 in Figure 10.12.b on the disturbed metal surface of the upper skin rivet hole. d) The SEM micrograph shows corner crack #1 in Figure 10.12.b. The arrow marks the site of crack initiation and the dashed line marks the fatigue crack front.

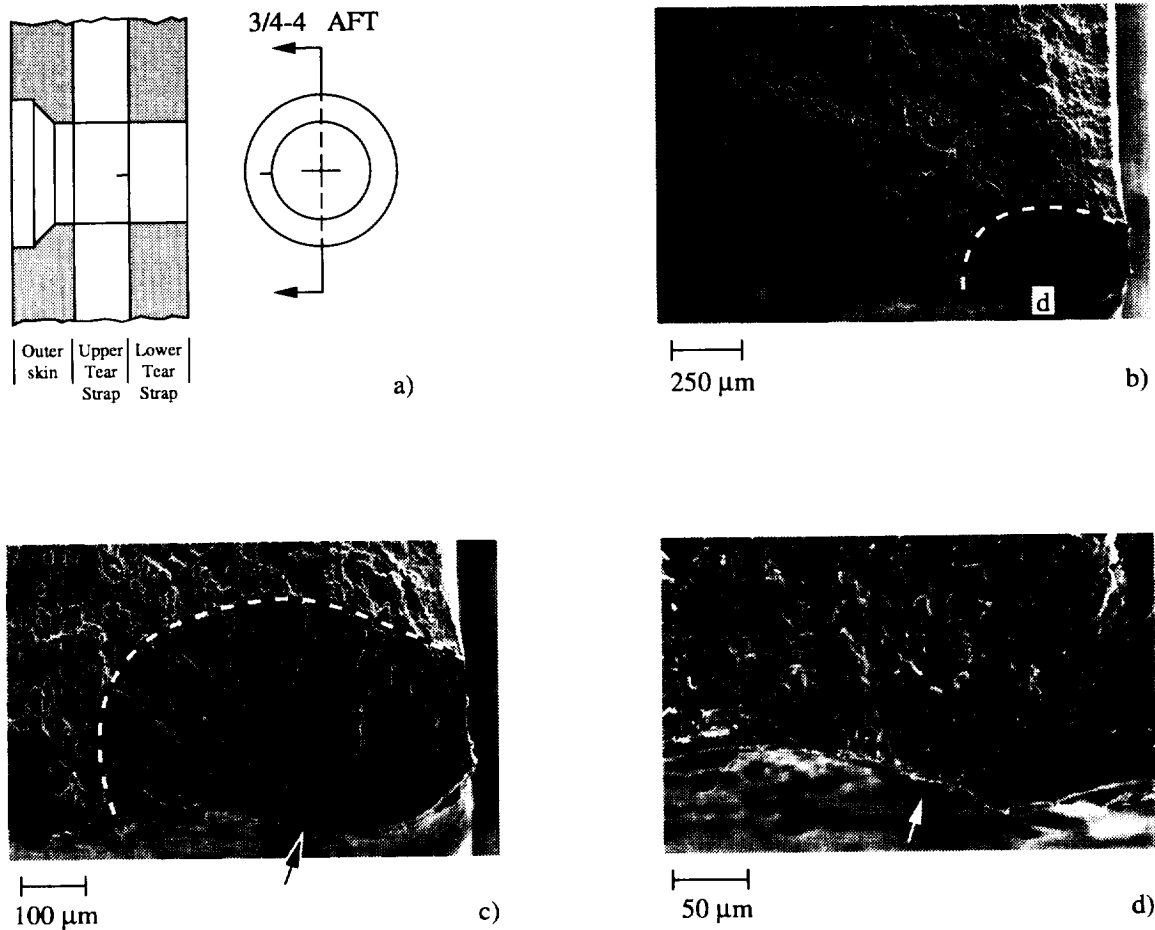
Figure 10.13 a) The schematic shows the rivet hole 3/4-4 configuration and the location of an upper T.S. fatigue crack oriented in the aft direction and about the 9 o'clock position. b) The SEM micrograph shows the upper T.S. fatigue crack located at the inboard corner of the rivet hole. The dashed line marks the fatigue crack front. c) The SEM micrograph shows the upper T.S. corner crack. The arrow marks the likely site of crack initiation and the dashed line marks the fatigue crack front. d) The SEM micrograph shows the region of crack initiation at high magnification, region "d" in Figure 10.13.b. The arrow marks the likely crack initiation site.

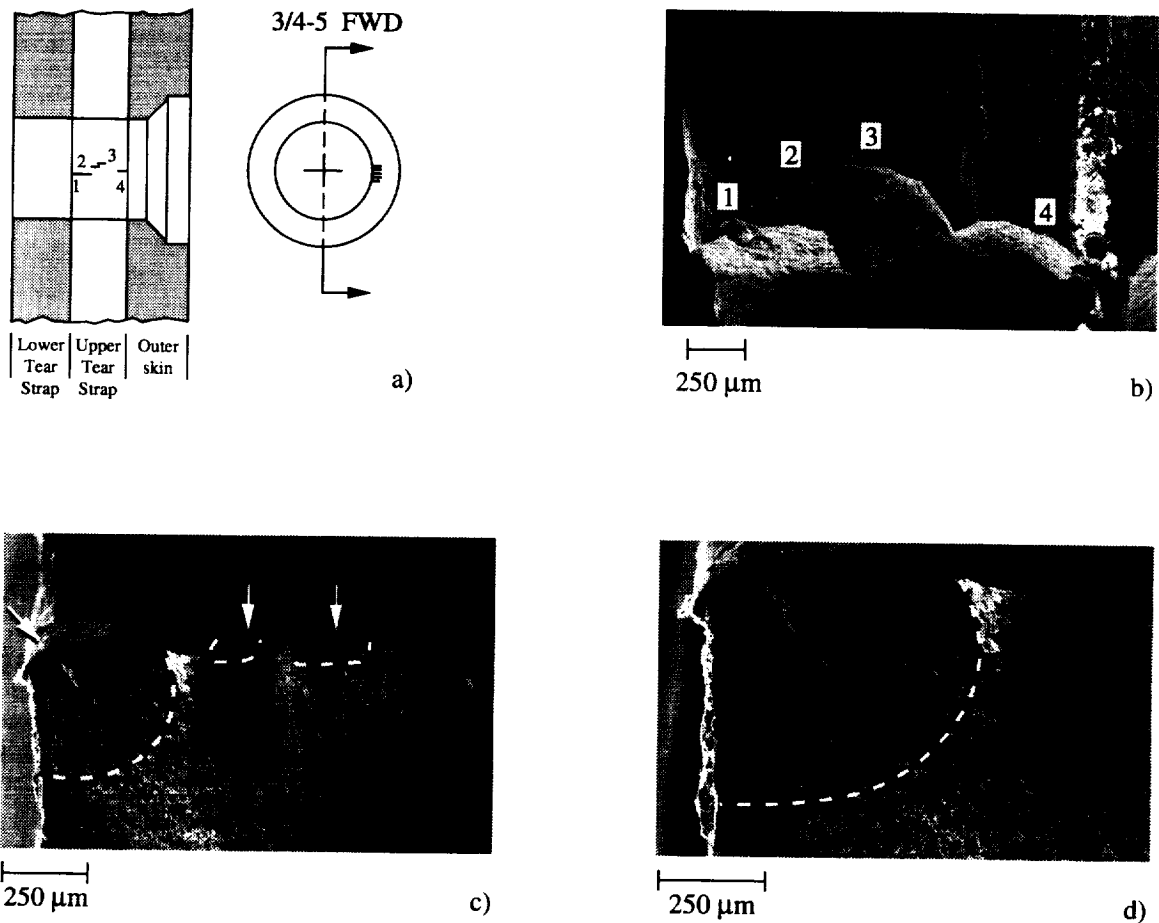
Figure 10.14 a) The schematic shows the rivet hole 3/4-5 configuration and the location of four upper T.S. fatigue cracks oriented in the forward direction and about the 3 o'clock position. b) The SEM micrograph shows the inside surface of the upper T.S. rivet hole. The main fracture surface is located at the bottom of the micrograph. c) The SEM micrograph shows three upper T.S. fatigue cracks located on the main fracture surface (arrows). Starting at the left, a fatigue crack initiated at the inboard rivet hole corner (crack #1), the middle arrow marks a surface crack (crack #3) partially hidden by a partially fractured ligament seen in Figure 10.14.b. The third arrow, located slightly to the right of center, marks the location of the third rivet hole surface crack (crack #4). Dashed lines mark the crack fronts. d) The SEM micrograph shows the inboard corner crack at higher magnification. The dashed line marks the fatigue crack front.
